UH-1N SALT WATER SPRAY INGESTION TESTS (CATEGORY II FOLLOW-ON TEST PROGRAM)

TECHNICAL REPORT No. 72-39

OCTOBER 1972

**AIR FORCE FLIGHT TEST CENTER
EDWARDS AIR FORCE BASE, CALIFORNIA
AIR FORCE SYSTEMS COMMAND
UNITED STATES AIR FORCE**

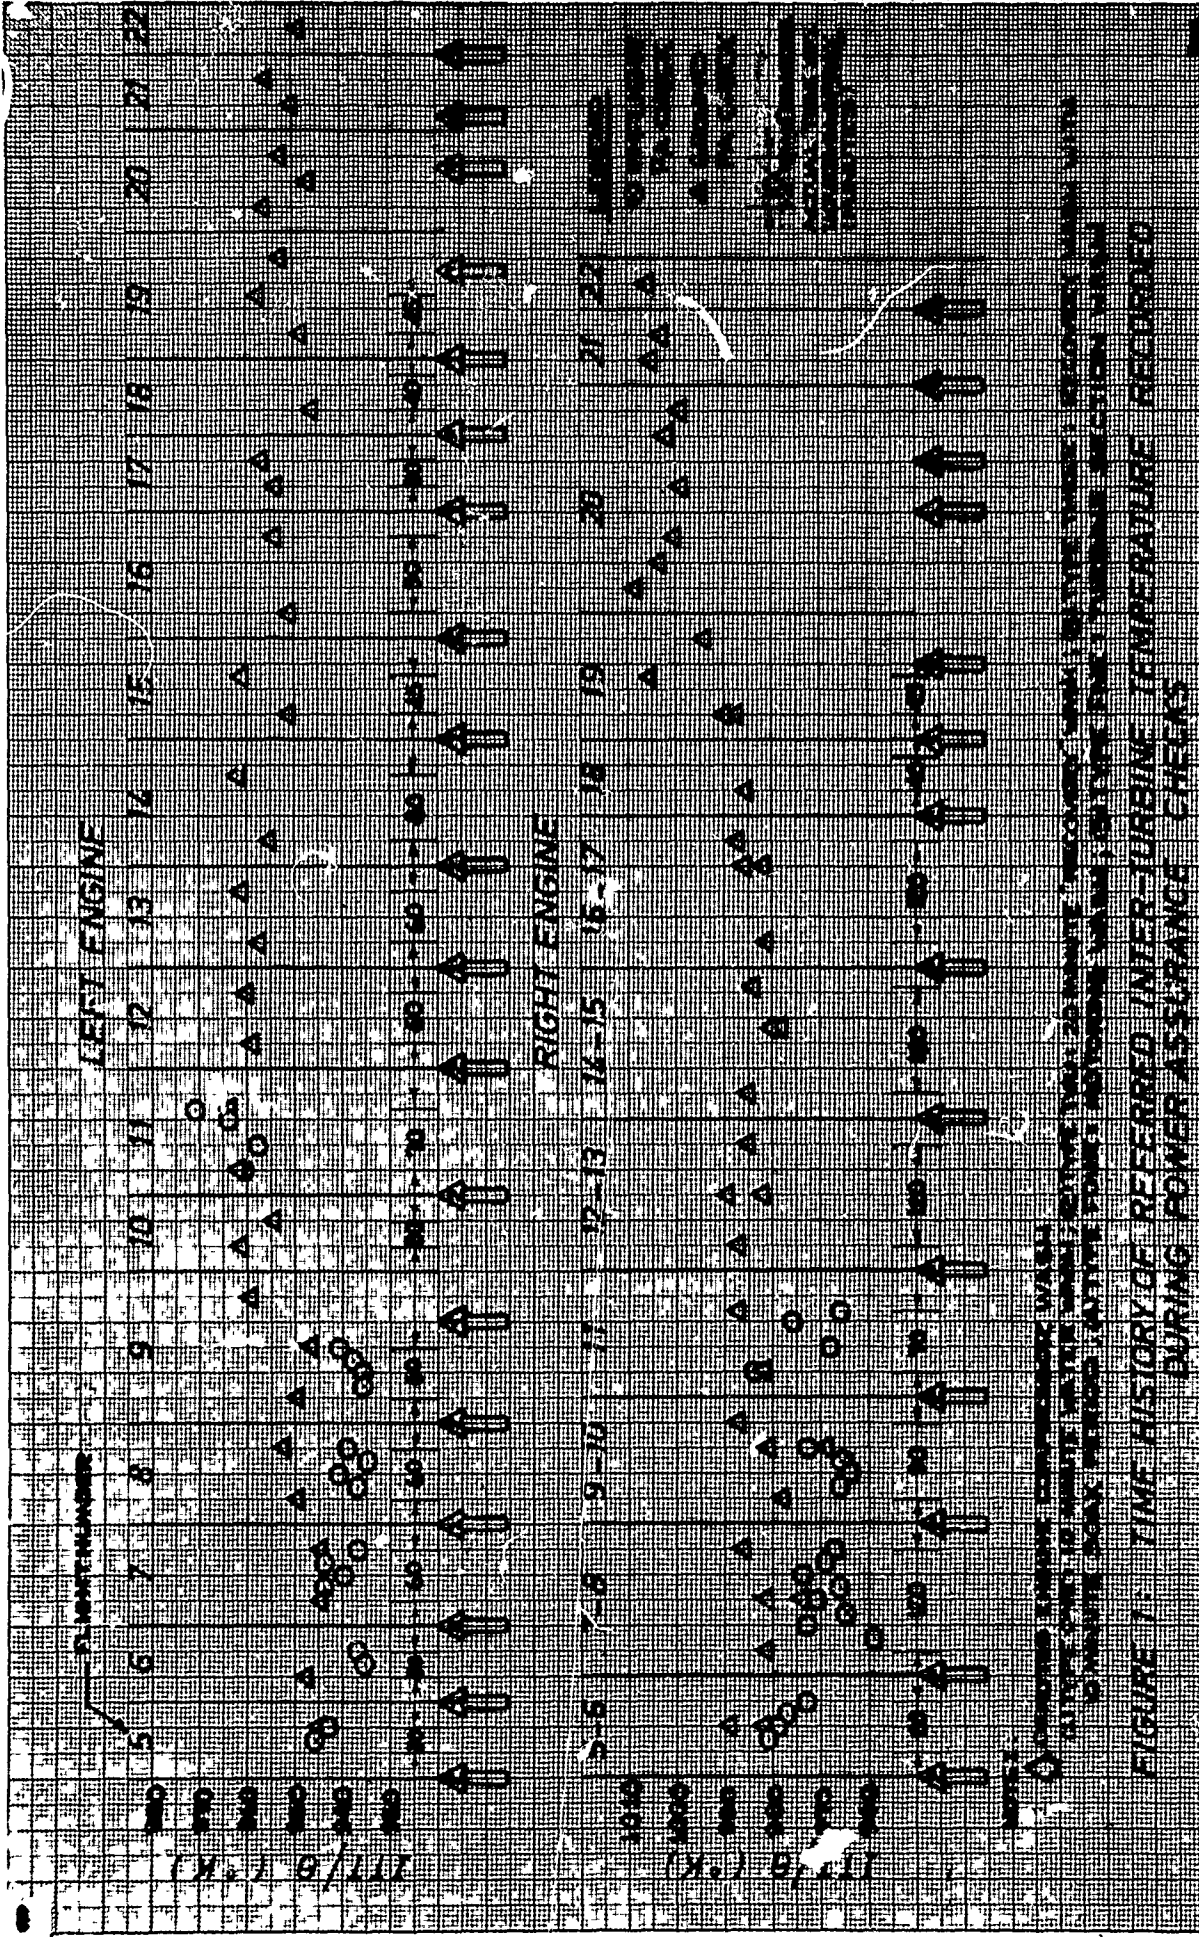
FIGURE 1. TIME HISTORY OF REFERRED INTER-TURBINE TEMPERATURE RECORDED DURING POWER ASSURANCE CHECKS

Figure 1 presents a time history of the performance parameter, ITT, for both engines during power assurance checks. Data from flights 1 through 4 have been omitted for both engines because these flights were of short duration and were troubled with a malfunctioning left engine ITT limiter.

Power assurance checks performed on both engines on the ground generally produced 10 to 20 degrees higher indicated ITT than those performed in flight. This made it impossible to compare the initial ground check with any of the subsequent inflight power assurance checks. A comparison was possible, however, between the pre-hover and the post-hover ground power assurance checks and between successive inflight checks.

Inflight power assurance checks did not correlate with the inflight topping power checks. During flight 7, the left engine lost approximately 1 percent torque during successive topping checks while the ITT decreased approximately 7 degrees C during power assurance checks. During flight 9, the left engine ITT increased 5 degrees C while topping checks showed almost a 2 percent loss in topping power torque. Flight 11 was flown almost entirely in wind conditions insufficient to cause salt water spray impingement on the helicopter. During this flight the left engine showed no torque degradation, but the ITT increased 10 degrees C during successive power assurance checks.

A similar lack of correlation existed on the right engine. During flights 7 and 8, the right engine exhibited no power loss for the first 1 1/4 hours, then showed a decrease in torque of almost one percent after 1 1/2 hours and almost 2 percent after 1 3/4 hours. The inflight power assurance checks did not reflect the same marked change in ITT during the second hour of the hover, but showed an increasing/decreasing variation within a 10-degree C band for almost the entire flight and a consistent decreasing trend during the last 30 minutes of the hover. During flight 11, the right engine also showed no loss of topping torque; however, the right engine ITT decreased almost 20 degrees C during power assurance checks.

For these reasons, the practice of performing inflight power assurance checks was abandoned. Power assurance checks performed on the ground appear to be more reliable. Figure 1 shows the post-hover power assurance check generally yielded a higher value of ITT than the pre-hover check. The increase is, however, generally small, being on the order of 5 to 10 degrees C.

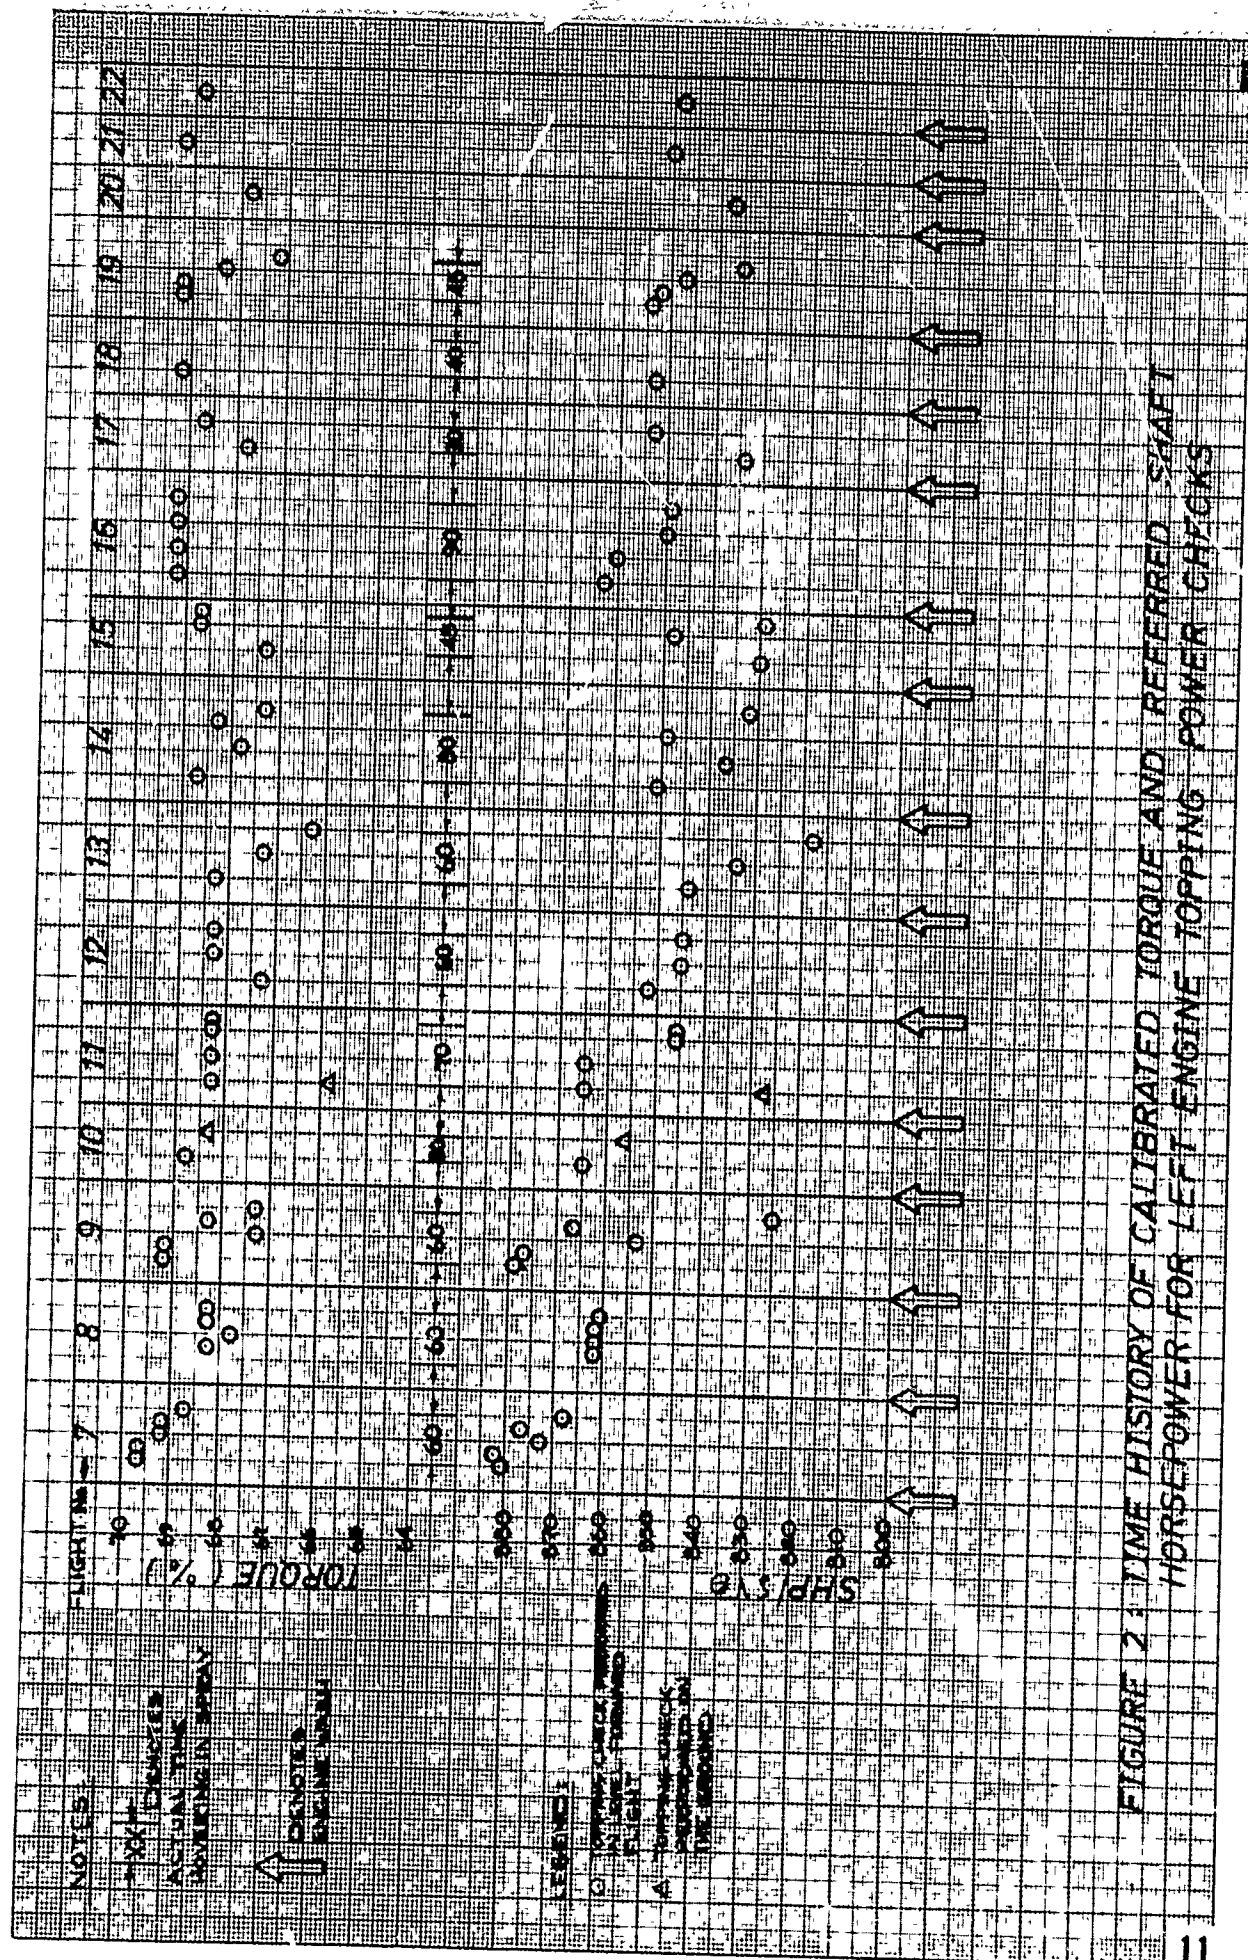
FIGURE 2: TIME HISTORY OF CALIBRATED TORQUE AND REFERRED SHAFT HORSEPOWER FOR LEFT ENGINE TOPPING POWER CHECKS

Figure 2 presents a time history of calibrated torque and its derivative, referred shaft horsepower, $(SHP/\delta\sqrt{\theta})$, for all topping power checks performed on the left engine at NAS North Island. Figure 3 presents the corresponding values of referred gas generator speed $(N_g/\sqrt{\theta})$ and referred inter-turbine temperature (ITT/θ) . Data from flights 1 through 6 have been omitted because of the short duration of these flights and because of severe fluctuations experienced as a result of a malfunctioning ITT limiter.

The maximum power loss observed after two hours of hovering was two percent torque. With the exceptions of the left engine power loss during flight 13 and the power loss of both engines during flight 19, the maximum power loss after 60 minutes was 1 percent torque. It is concluded that engine power loss as a result of sustained hovering in salt spray occurs at the rate of 1/2 to 1 percent torque per hour of hovering. Since two hours of hovering is beyond the fuel endurance limit of a UH-1N, an aircraft with two percent excess torque demonstrated during its initial pre-hover topping check should be able to perform its mission without power degradation to below minimum acceptable values.

An aircraft which has less than two percent excess torque could experience power degradation to below acceptable values during its mission. In this case, topping power checks are required after predetermined lengths of sustained hovering in salt water spray. Prior to initiation of hovering in salt water spray, a topping power check should be performed to determine initial acceptability. If an engine demonstrates two percent excess power or more, its condition need not be checked during the salt water mission. If the engine shows less than 2 percent excess power, a topping power check should be performed after each 30 minutes of hovering in the salt spray. (R 5)

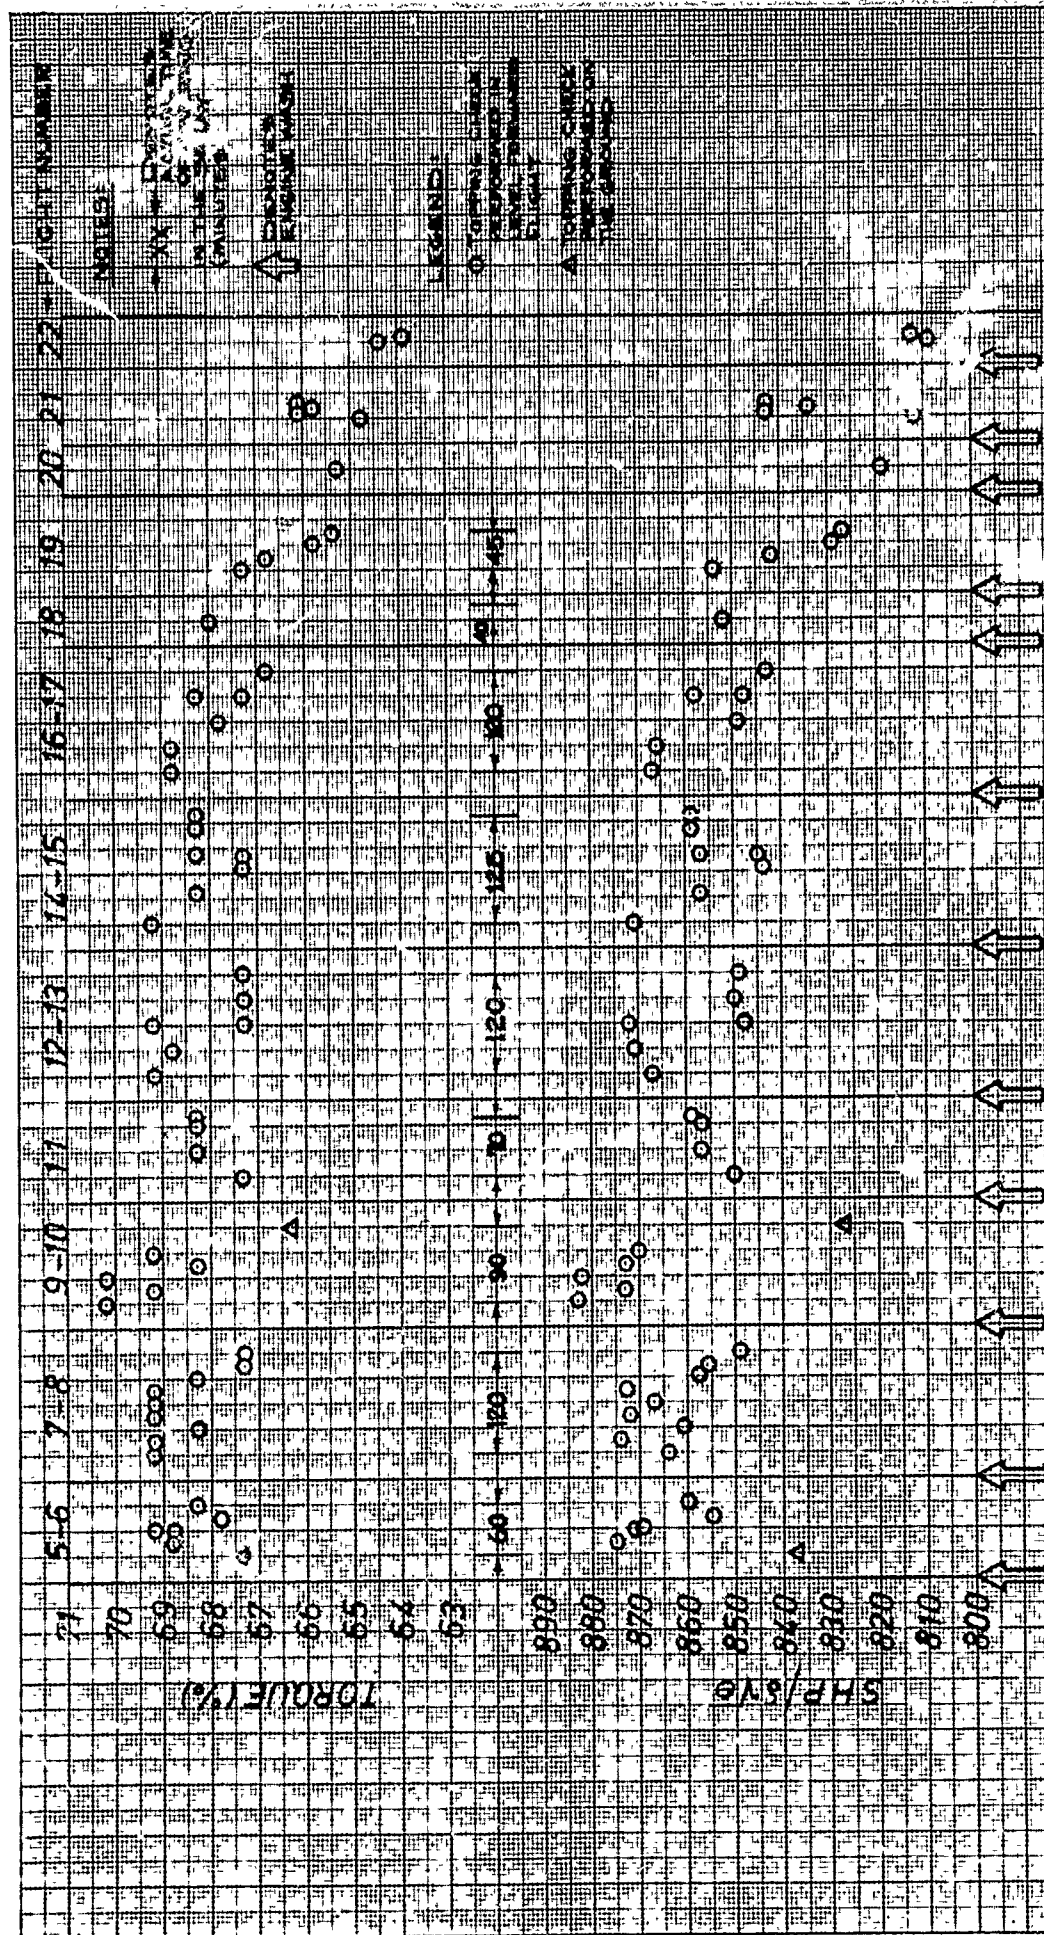
FIGURE 4: TIME HISTORY OF CALIBRATED TORQUE AND REFERRED SHAFT HORSEPOWER FOR RIGHT ENGINE TOPPING POWER CHECKS

Figures 4 and 5 present the time history of these parameters for topping power checks performed on the right engine. Data from flights 1 through 4 have been omitted due to the short duration of those flights. Table II summarizes the hover time and power degradation experienced by each engine during each flight. For purposes of analysis, an engine compressor was assumed to have been cleaned by an engine wash and, therefore, returned to a "zero hover time" condition after each engine wash.
